# **TRACK SAFETY PATROL FEB 2020**

# **YARD AND SURROUNDING TRACK**

Assessed and Written by CNDR Fairlie

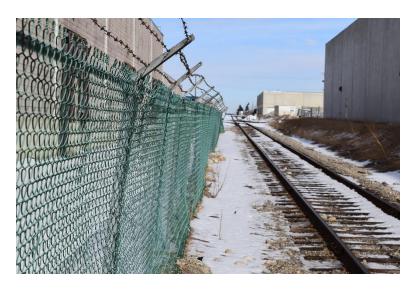
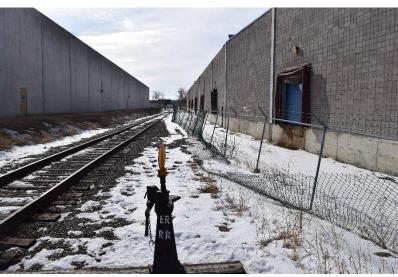
1. Top of barbed wire fence within striking distance of car rider. – Place Restricted Clearance sign and repair fence. East Foothills lead. Green fence slightly north of 72<sup>nd</sup> Ave. 300-foot stretch of fence between E500 and E600 leads. West side of rail. Barbed wire within 1 arm's length of tracks. Please add restricted clearance sign to west side of rail until fence is repaired.

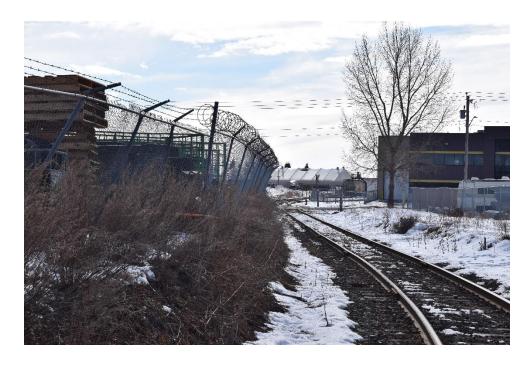
# 2. Razor wire close to riding height. – Repair Lean of Fence or Place Restricted Clearance sign

Located along East Foothills. North of 74 Ave crossing. West side of rail. Top of fence razor wire leans close to car riding height. Please repair lean in fence or place Restricted Clearance sign. Hazard is within 1 arm's length of rail.

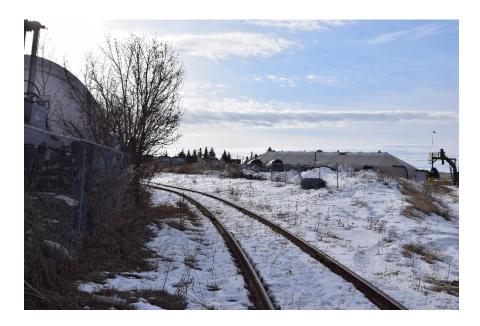
#### 3. Tree branches within striking distance of rider – Trim branches

Tree branches hanging close to track on North side of track. Near E505 switch on E500 lead. North side of rail

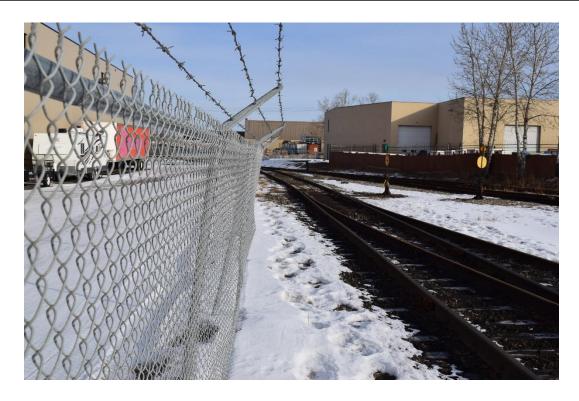
#### 4. Barbed wire on fence within striking distance of rider – Place Restricted Clearance sign

E600 lead. West of E605 switch. East of 40 Street crossing. Top of fence within 1 arm's length of rail.

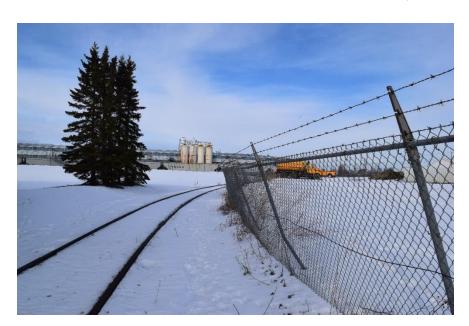
5. Barbed wire on fence and tree branches within striking distance of rider – Place Restricted Clearance Sign

E700 lead. East of E700 lead switch. Please also trim nearby trees.

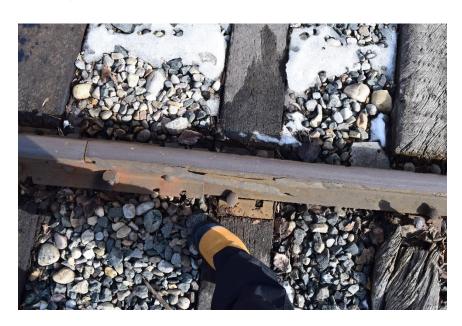
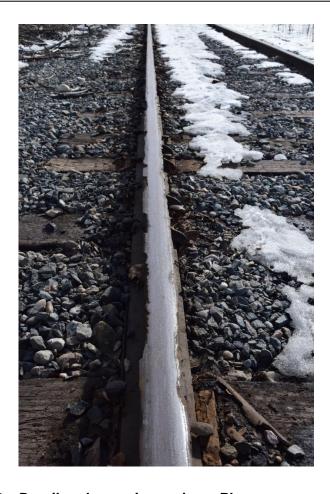
#### 1. Damaged rail/poor visual condition – Please assess and confirm safe or unsafe

Track around F309 switch looks very worn. Signs of rust damage. Large pieces of the head of the rail (1+ feet in length) are missing or ready to break off. Damage is on both inside and outside portions of the rail.

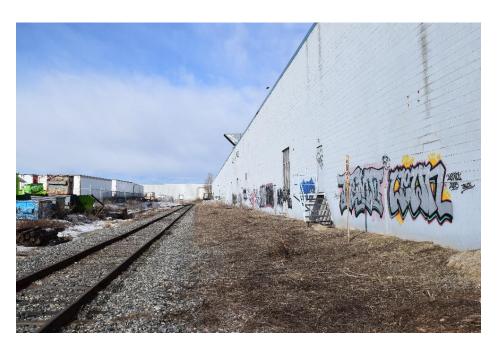
# 2. Derail no longer in service. - Please remove derail sign.

Derail sign located between the F300 and F303 switch. Please remove. No longer needed.

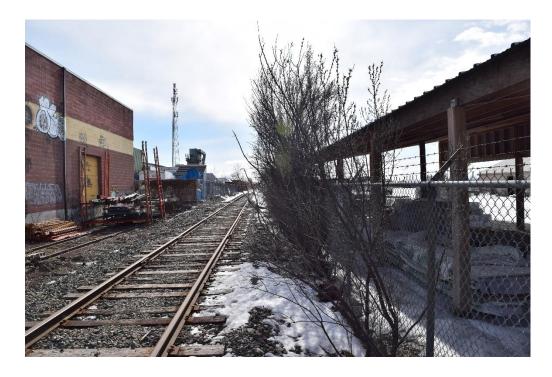
#### 3. Overgrown Branches behind Boss Lubricant – Please trim.

Bushes on west side of rail need trimming. Within one arm's length of rail.

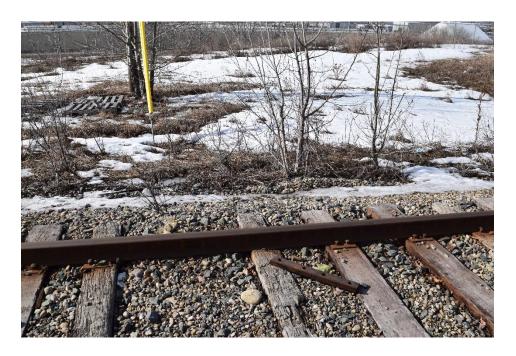
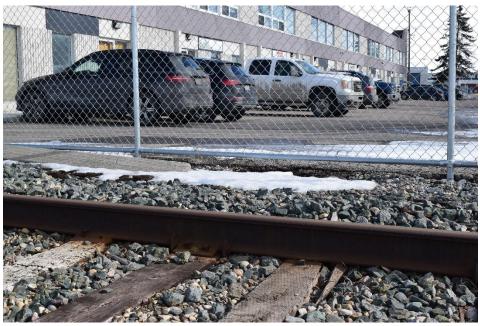
## 4. Missing Tie and Tie Plate - Please assess and confirm safe or unsafe

Located near the F317 and F329 switch. Missing tie and tie plate. Other sections of track nearby are missing tie plates or multiple nails to fasten the rail in place.

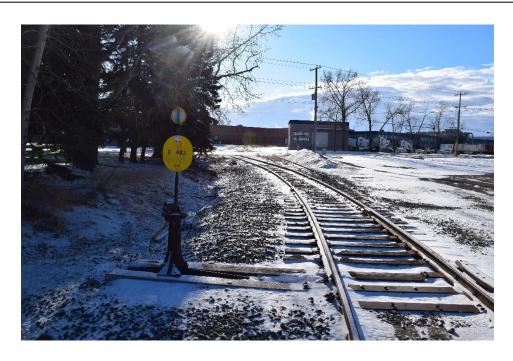
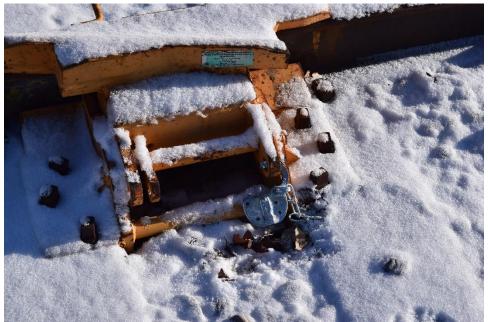
# 5. Damaged Derail Lock - Please replace

The lock on the derail past the F403 switch does not lock shut. It is damaged. The derail could be easily tampered with and not provide protection. Please replace the lock with a new one.

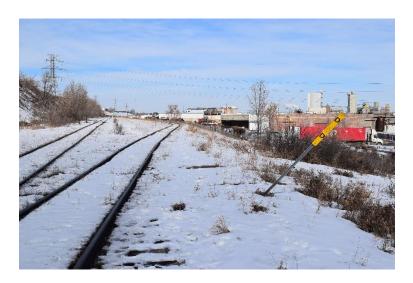
#### 1. Double Derail no longer in service. - Please remove derail sign.

Double Derail signage located near M000 Switch. Very confusing especially at night or in poor weather. Derails are no longer in place. Please remove signage

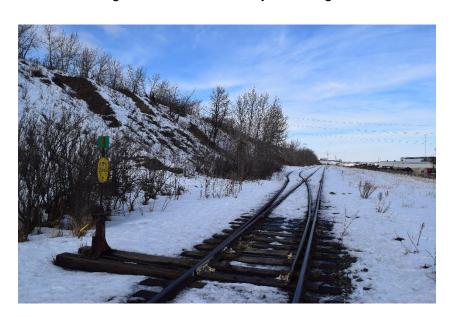
#### 2. Branches along runaround turnouts strike riders on South side of rail - Please trim.

Please trim the branches on the south side of the rail on the West and East M0005 switches. The trees along the turnouts strike anyone riding cars on the switch side.

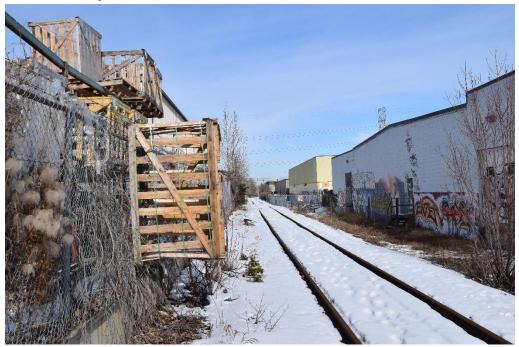
#### 3. Shipping crate hooked on fence. Major risk of riders being struck. - Please remove.

Along H300 lead before H314 switch. Large shipping crate fell from nearby storage rack and is lodged on fencing on West side of track. Please remove if the company who shares the fence has not already removed. *Removed ~ March 6, 2020*

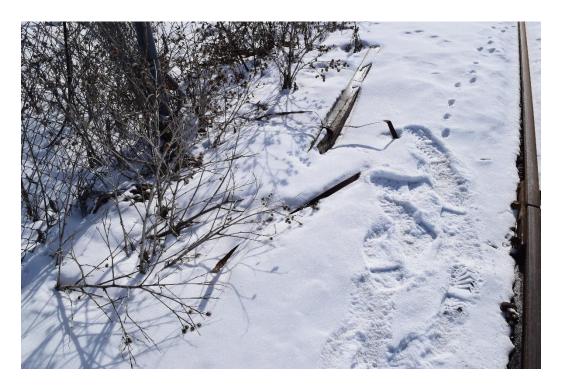
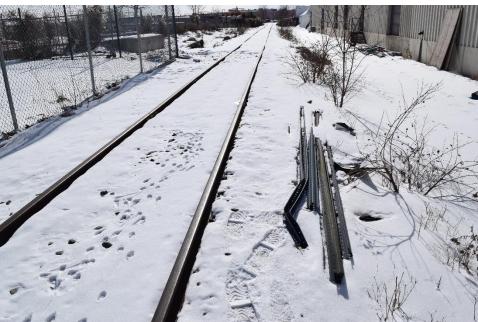
#### 4. Tin straps buried in ice and other debris around rail - Please remove

Along H400 lead. Tin strap forms "loop" in snow that is lodged in ice. Tripping hazard. Other heavy metal debris within 1 to 2 feet from rail. Partially buried and cannot be seen when covered by snow. Please remove.

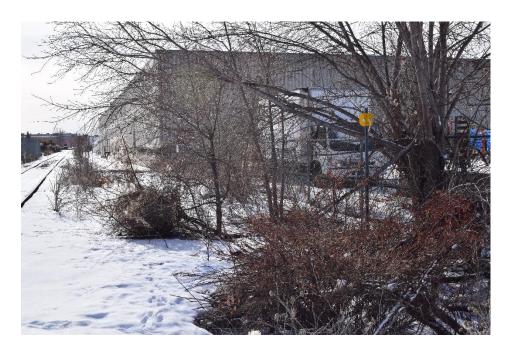
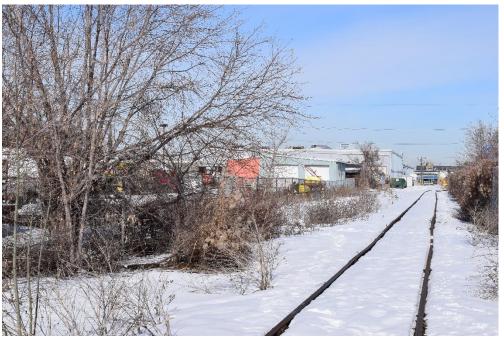
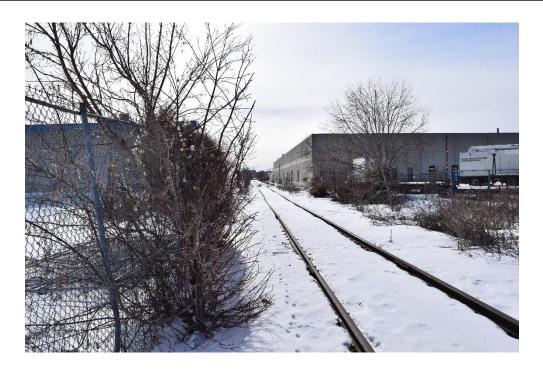
# 5. Restricted Clearance sign hidden by bushes – Please remove or make visible.

Restricted clearance sign completely hidden at night. Likely was in place for a torn-out track. Please remove or place in visible location.

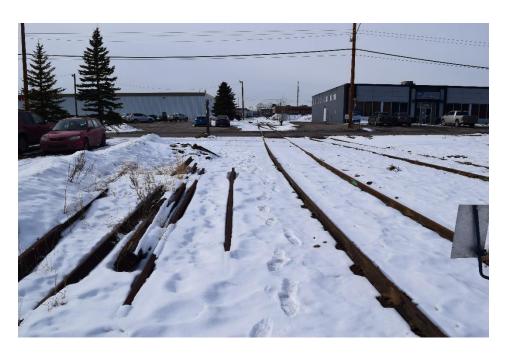
#### 6. Loose rail close to track – Please move further distance from track

Highfield Industrial lead. Loose rail 2-3 feet from track in area frequently travelled on foot when working. Please move as far away from rail as possible. Tripping hazard leading to possibly falling into movement.

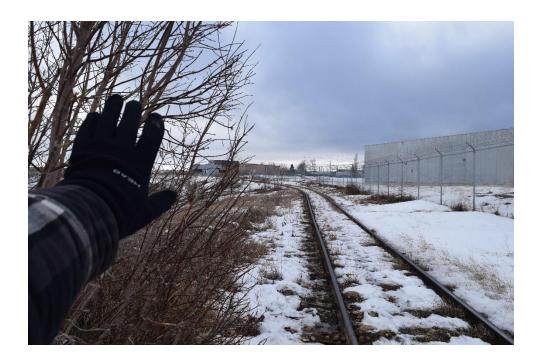
## 7. Overgrown bushes and debris strike rider on both sides of track - Please trim

H500 Lead to H506 switch. Several trees on either side of the track strike the rider. Please trim.

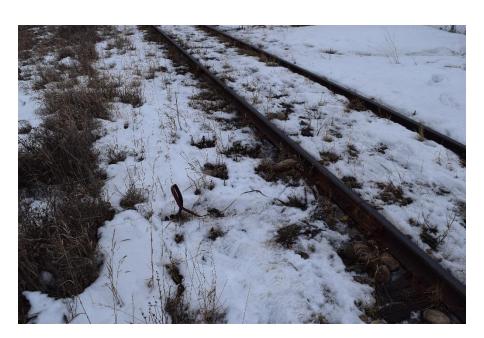
## 8. Metal tin straps and other debris on ground creating tripping hazard – Please remove

Also along H500 Lead. Tin metal strapping, loose rail pieces, construction debris, etc on ground.

The tin strapping is particularly dangerous. Frozen into ice and not possible to remove without tools. Please remove.
